# AVRO VULCAN

1952 onwards (B2 model)

## Owners' Workshop Manual

An insight into owning, restoring, servicing and flying  
Britain's legendary Cold War bomber

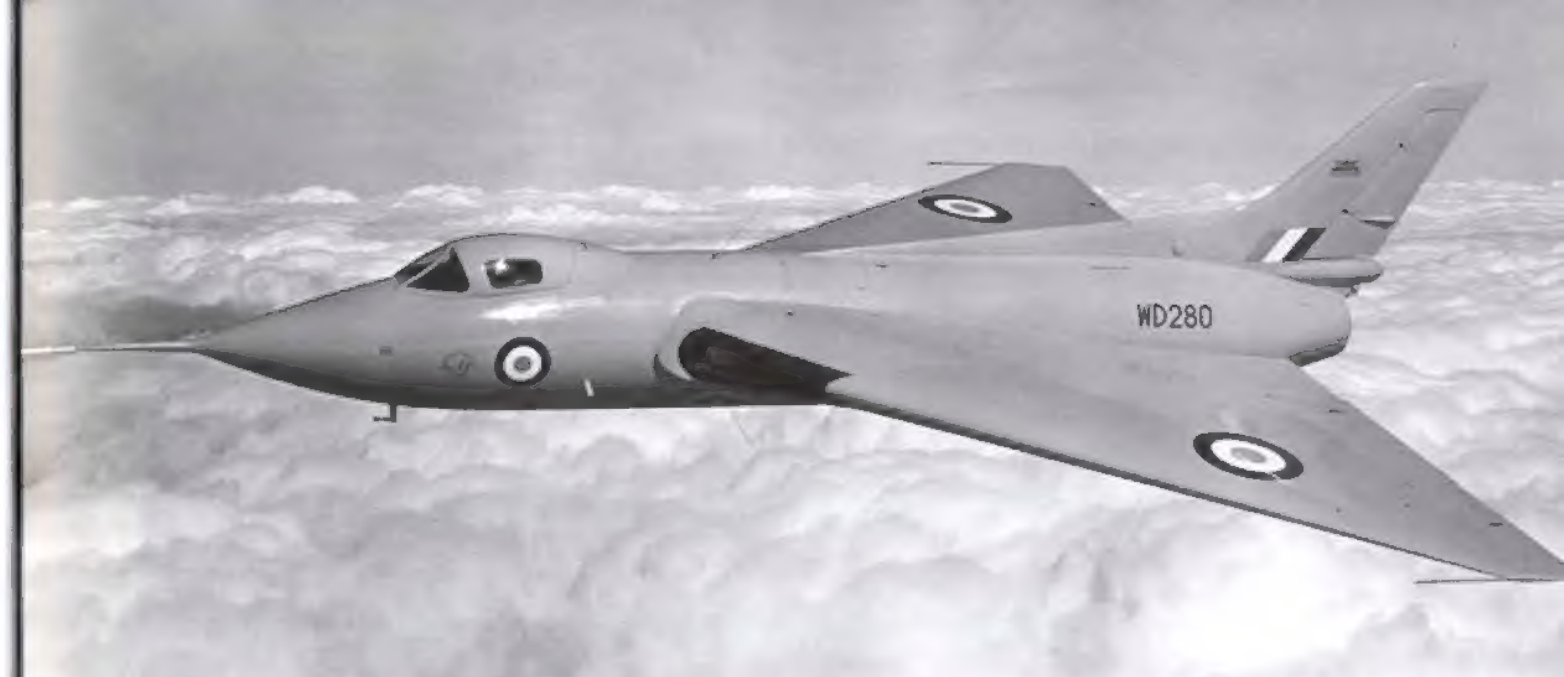
**ABOVE** WD280, the third flying scale model to be built, had representative air intakes and was used to test handling at high speeds.

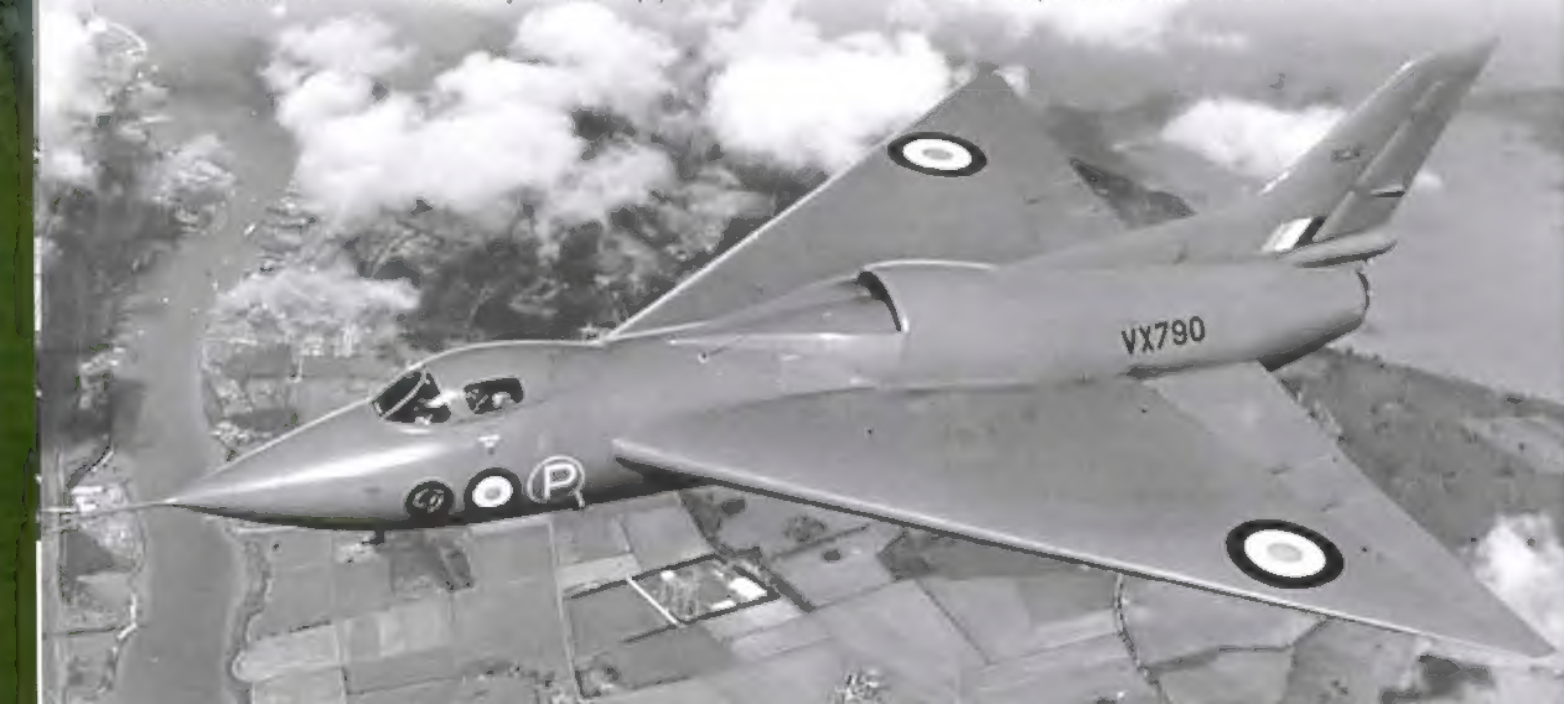
**BELOW** VX790, the second of the flying scale models of the Avro 698 bomber, was invaluable in testing the low speed handling of the full-sized aircraft. AHT

The loss of the first Avro 707 imposed delays on the work on the second scale model, VX790, which began flying in August 1950. This aircraft, designated the Avro 707B, was designed to investigate the low speed handling characteristics of the delta wing. The nose was made longer and thinner than on the first 707, and the wing sweep angle was increased slightly. Also, the elevators and the air brakes were redesigned. However, like the first aircraft, the 707B had a dorsal air intake just in front of the fin. That intake position caused engine problems due to its location and its inability to cope with turbulent air streaming back from the cockpit canopy. Later the 707's air intake was repositioned but, even after this modification, it was never really satisfactory.

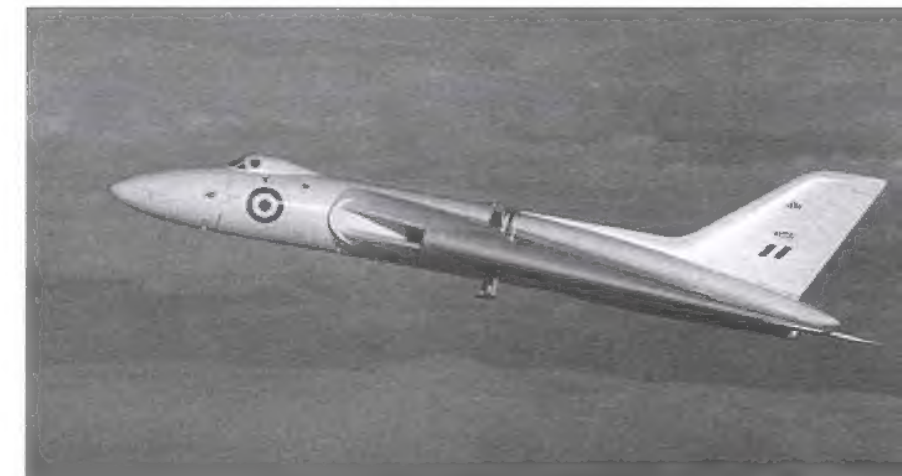
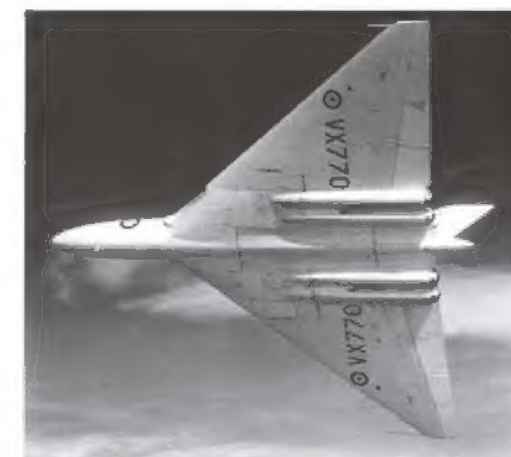
**ABOVE AND LEFT** These close-up air-to-air shots of the prototype Avro 698 show the advanced lines for its time of the new bomber. AHT

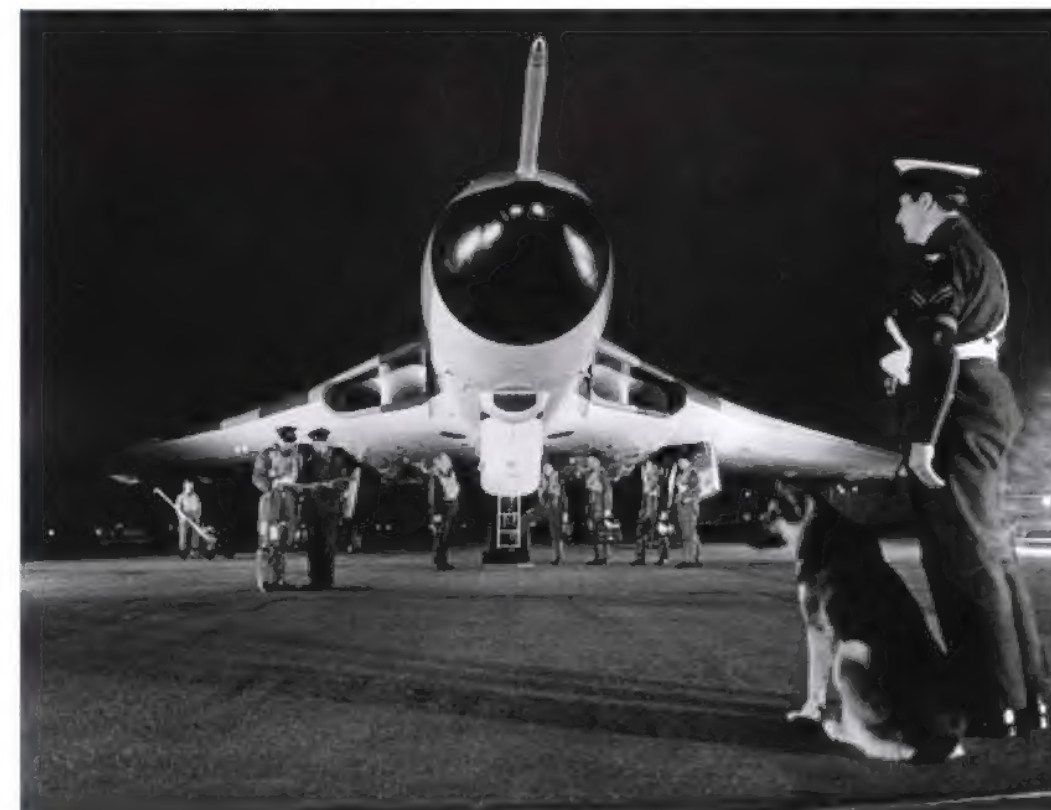
**ABOVE** The Vulcan B1A was a Mk 1 modified to carry the full suite of ECM equipment, and fitted with a bleed-air turbine to generate the necessary electrical power to drive these systems. This particular aircraft, XA907, served for some time with the Bomber Command Development Unit at RAF Finningley, where it was used to test the ECM and other systems due to be fitted to the B2.

Meanwhile the Vulcan B1s in service also underwent several upgrades. They were fitted with the more powerful Olympus Mk 104 engine developing 13,000lb of thrust. To enhance the Vulcan B1's ability to reach its targets, these aircraft were later fitted with the same electronic countermeasures suite as the B2, with the same bulged tail fairing to accommodate them (see Chapter 6). Vulcan B1s so modified were re-designated as Vulcan B1As.

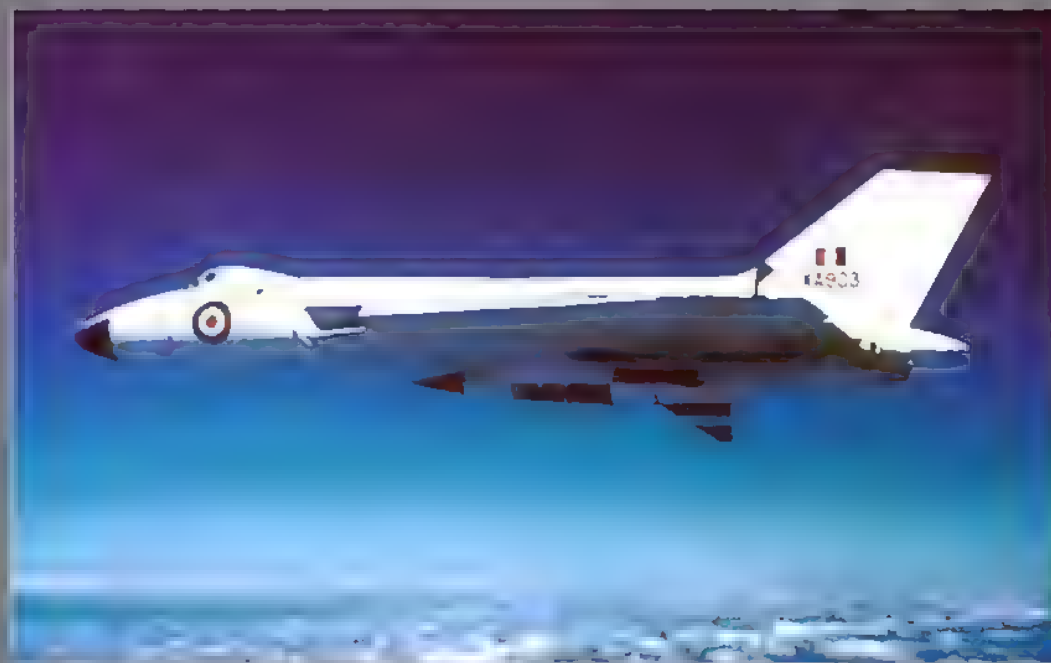
**RIGHT** XA903, a Vulcan B1, was used during the initial carrying and release trials of the Blue Steel missile over the Aberporth range in west Wales.

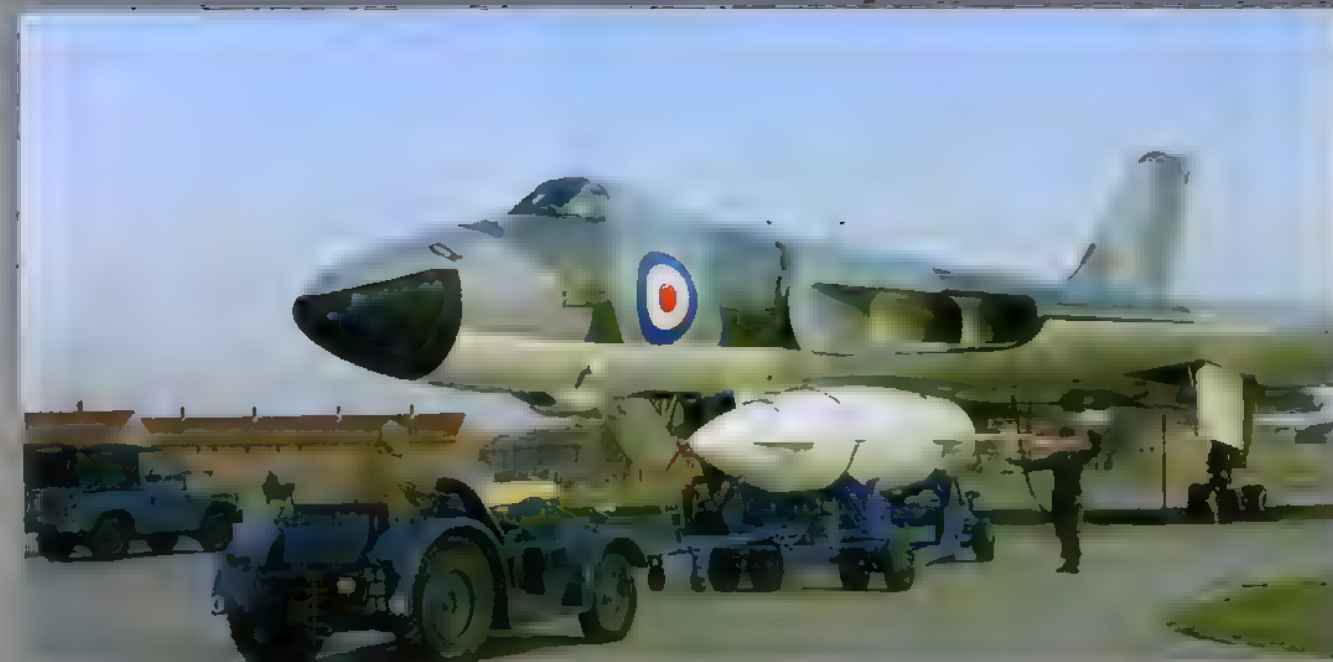
In parallel with the Mk 2 V-bomber programme, the RAF had placed an order with Avro to design and build an air-to-surface missile to provide a stand-off attack capability for Mk 2 V-bombers. Designated Blue Steel, the weapon was 35ft long, it had a stub wing with a span of 13ft and at launch it weighed 17,000lb. The missile had a maximum effective range of about 100 nautical miles if launched at altitudes around 48,000ft, or about half that distance if it was launched at low altitude. The missile carried a Violet Club megaton range thermonuclear warhead, and it navigated itself to its target using a built-in inertial guidance system.

Blue Steel was powered by a de Havilland (later Bristol Siddeley) Stentor liquid fuelled rocket motor fitted with two combustion chambers. During the initial part of its flight, running on its main combustion chamber, the Stentor developed 16,000lb of thrust. This carried the weapon to 70,000ft and accelerated it to around Mach 2.5. Then the main combustion chamber cut out and the secondary chamber cut in, producing 4,000lb of thrust to sustain the weapon at that altitude and speed. Near the end of its four-minute flight-time the missile burst into its terminal dive to penetrate the target's defences at a speed of around Mach 1.8.

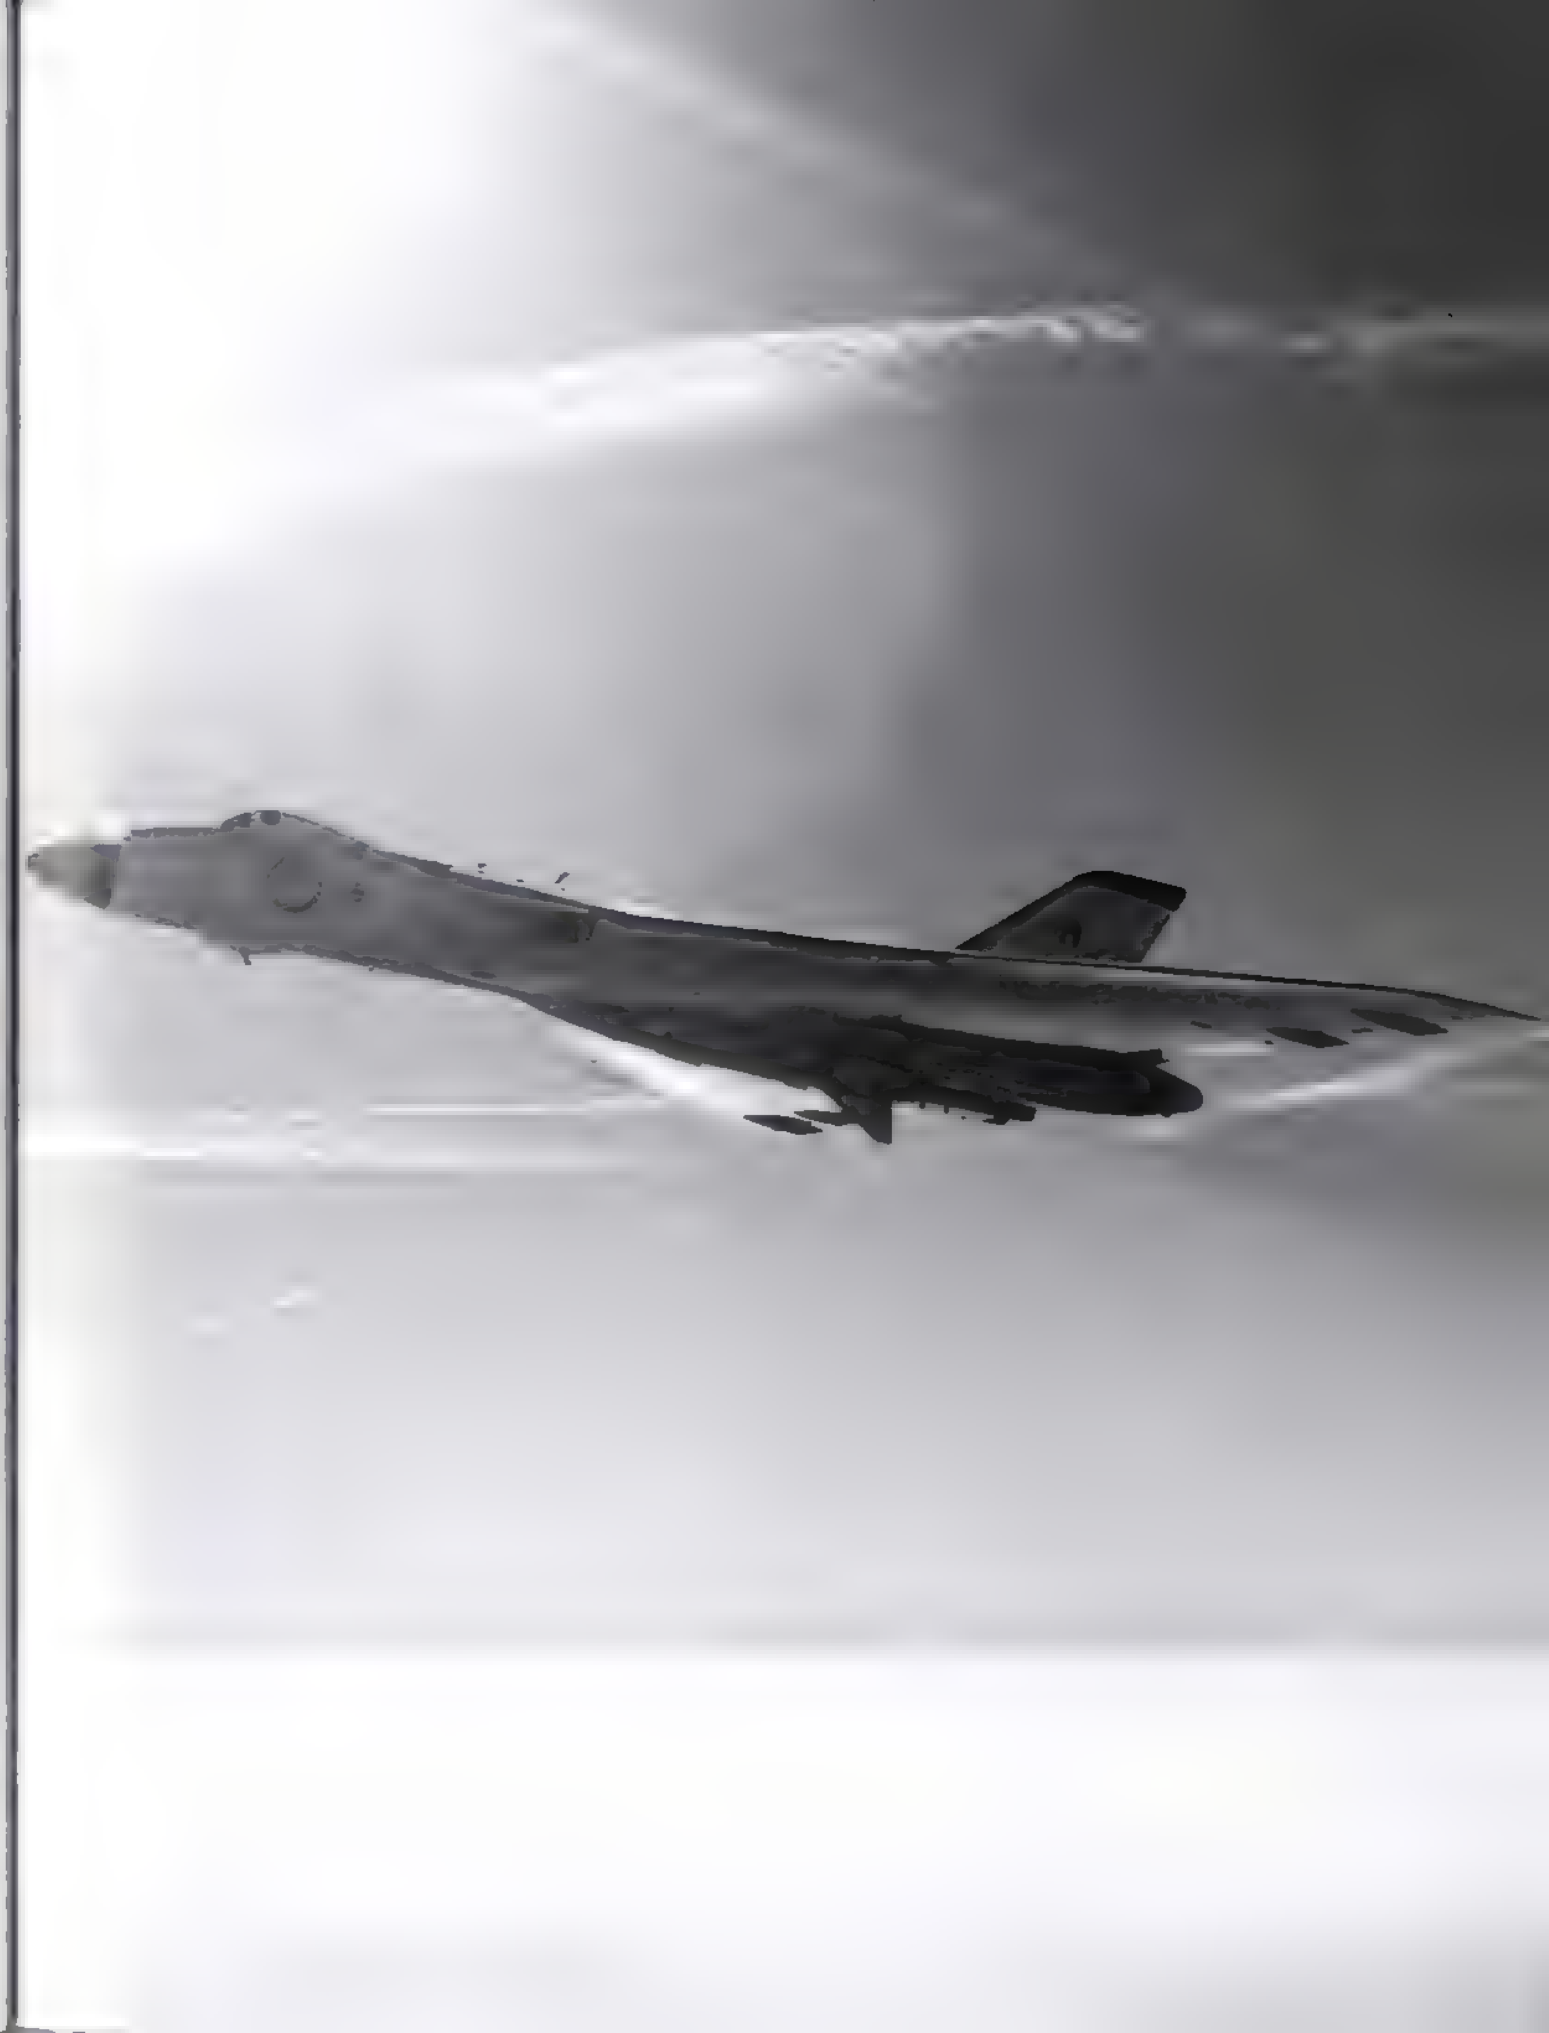
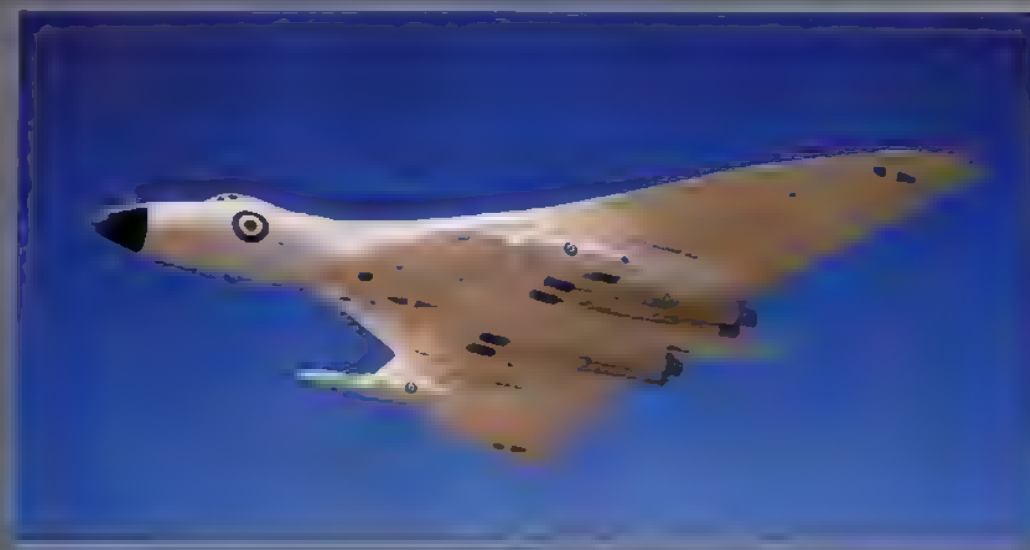
What might have been: B2, XH537 fitted with a pair of dummy Douglas Skybolt air-launched ballistic missiles mounted under the wings. The RAF planned to order the weapon from the US as a replacement for the Blue Steel missile, but the Skybolt had a troubled development phase. Eventually the US government decided to cancel the programme. PRM Aviation

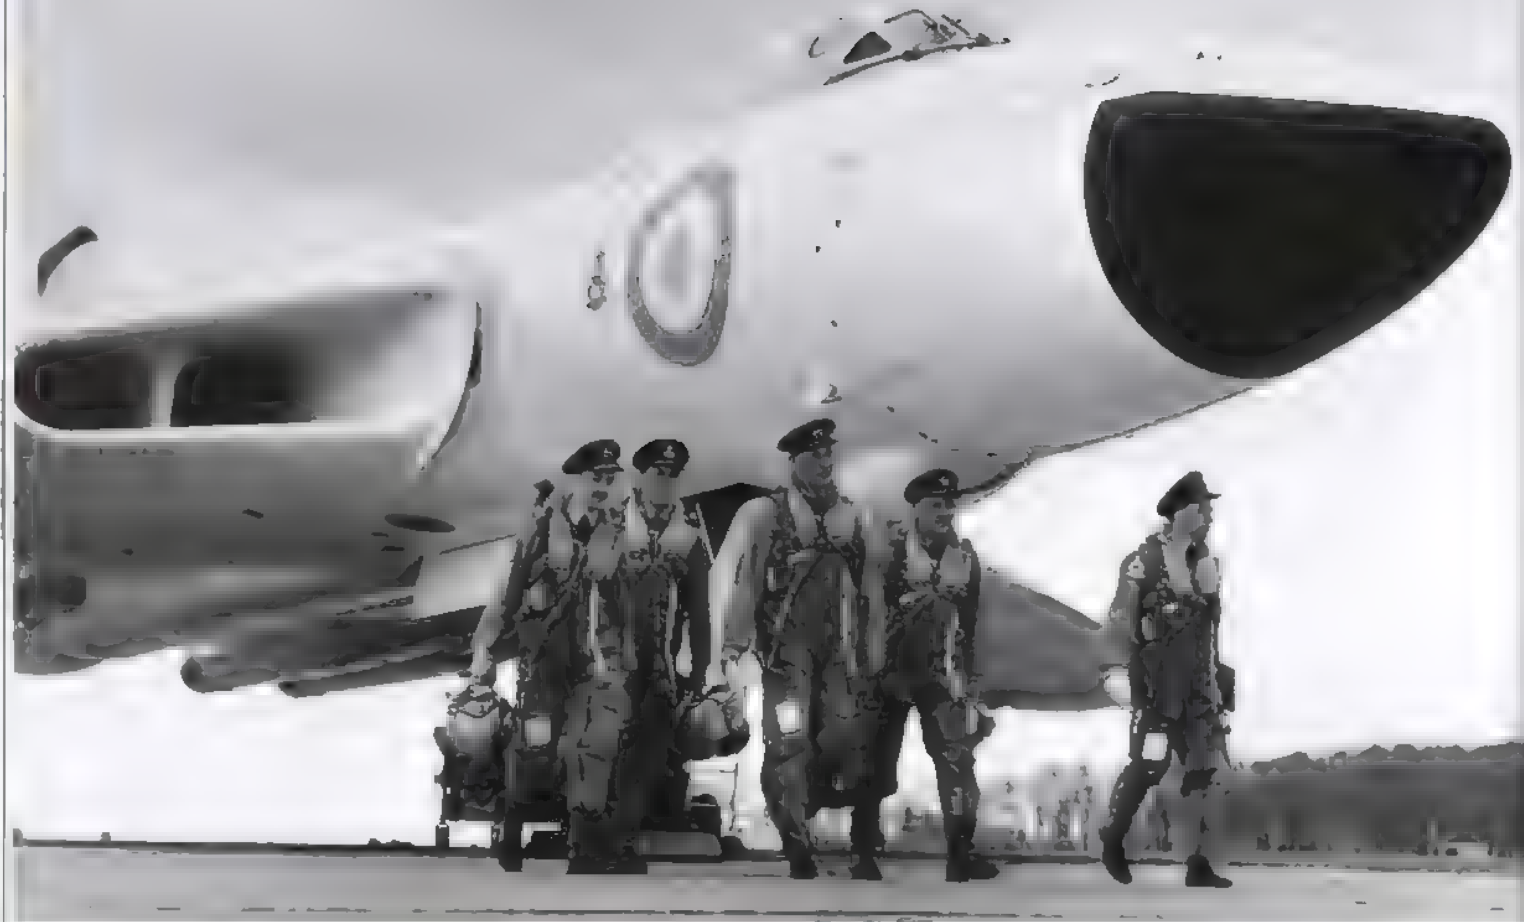
**ABOVE** The crew of a Vulcan B2 of No 27 Squadron at RAF Scampton leave their aircraft after a high altitude training sortie. Each man wears a partial pressure jerkin, with a built-in yellow life jacket. The modified anti-G suit trousers are worn inside the flying overalls and cannot be seen.

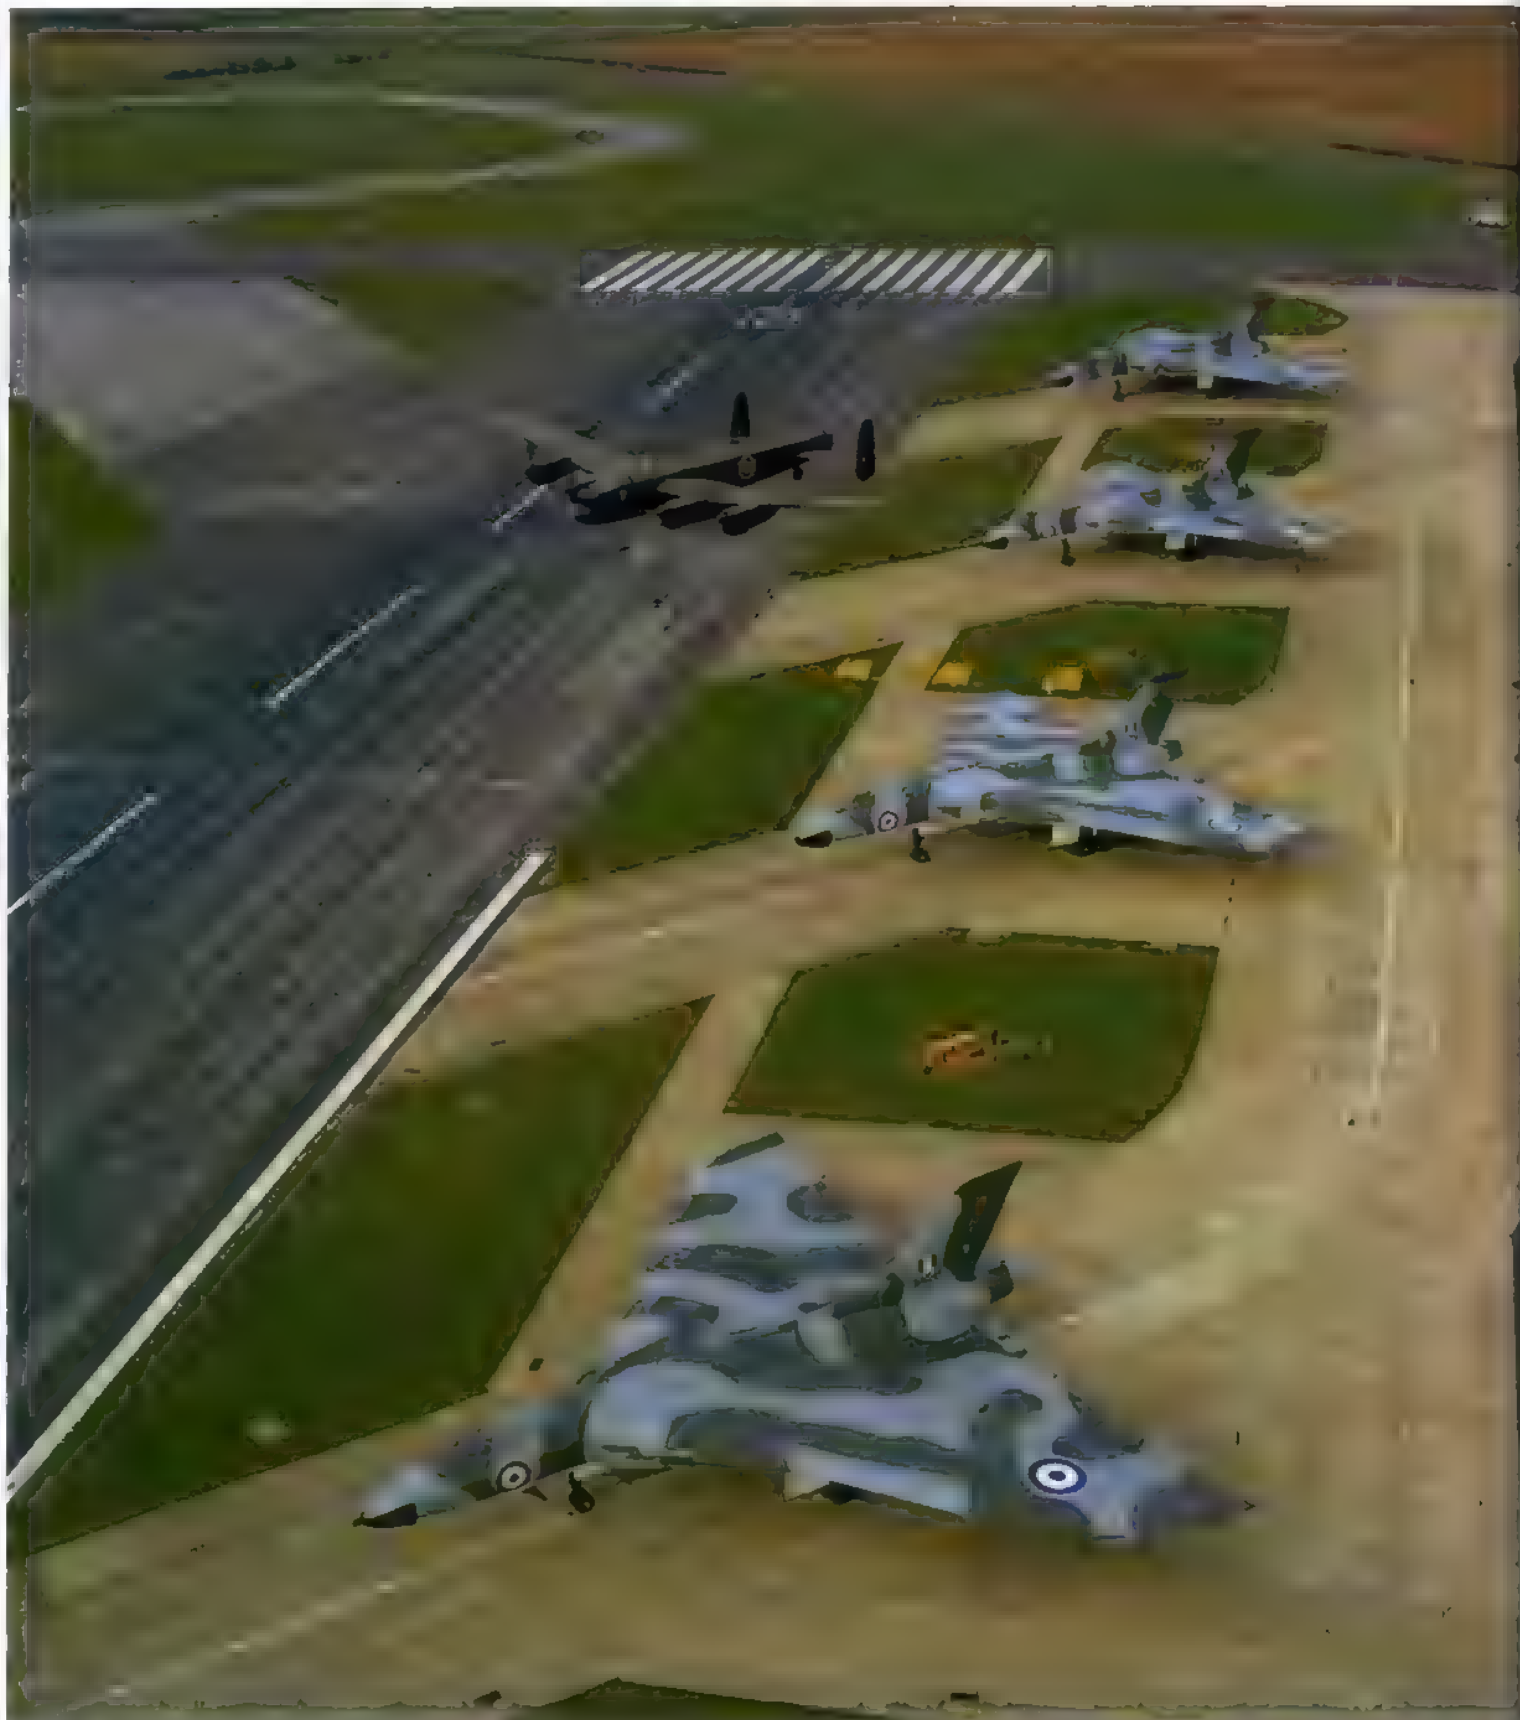
**ABOVE** Bad day at RAF Finningley, 18 April 1966. The crew had boarded XH556 and begun the pre-engine start checks, when a freak electrical fault initiated the undercarriage retraction sequence. The main wheels started to fold and for a brief time the nose wheel leg bore much of the weight of the Vulcan, before the structure collapsed and broke the back of the aircraft. One of the pilots jettisoned the cockpit canopy and the crew made hasty if undignified exits by sliding down the nose. Fortunately nobody was hurt, but the aircraft never flew again.

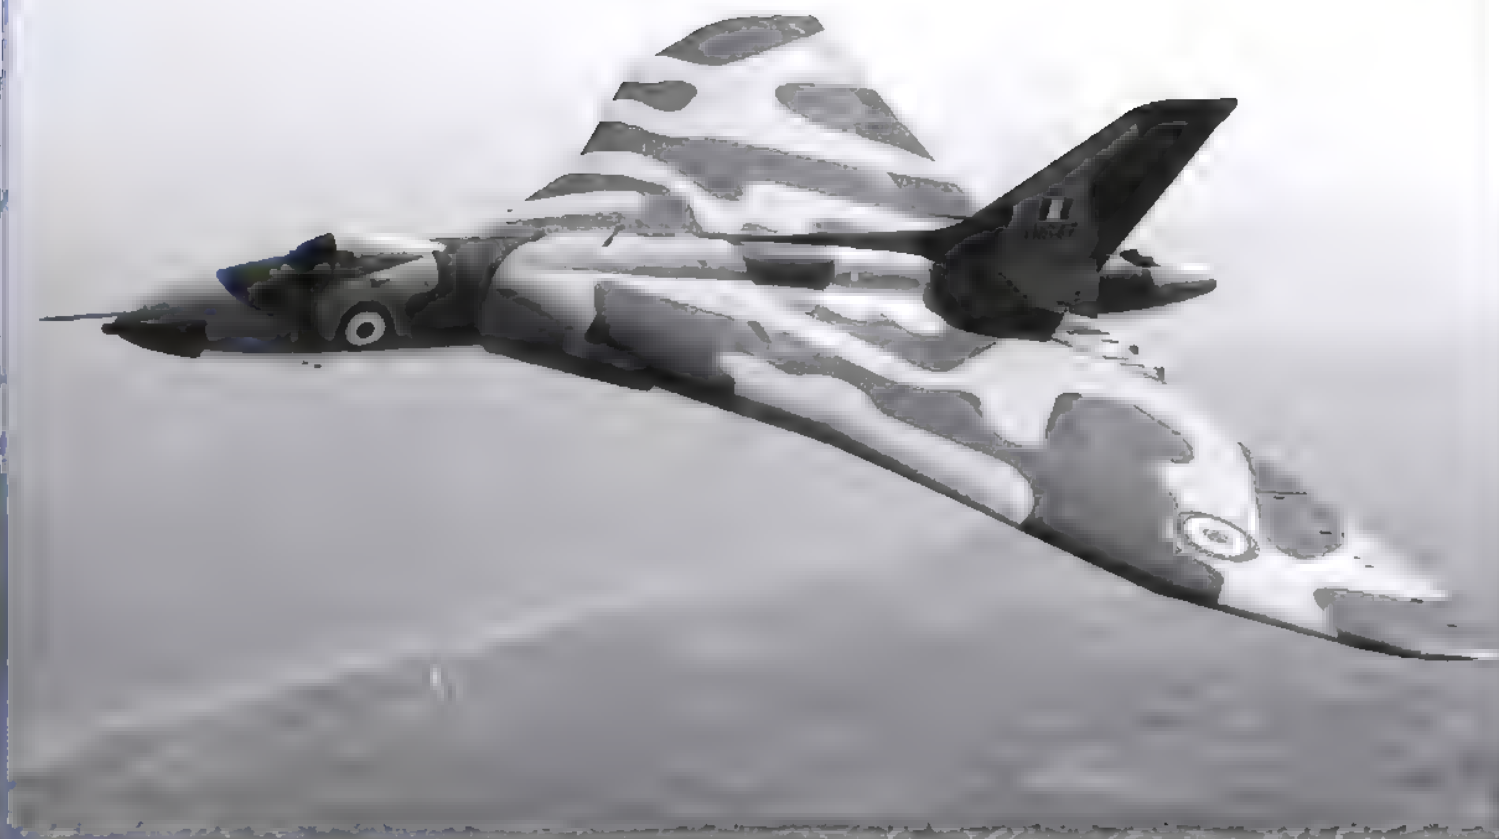
**ABOVE** XM647 served with the RAF Near East Bomber Wing based at Akrotiri, Cyprus, from January 1969 to January 1975. The small radome in the extreme nose, just beneath the refuelling probe, belongs to the terrain following radar.

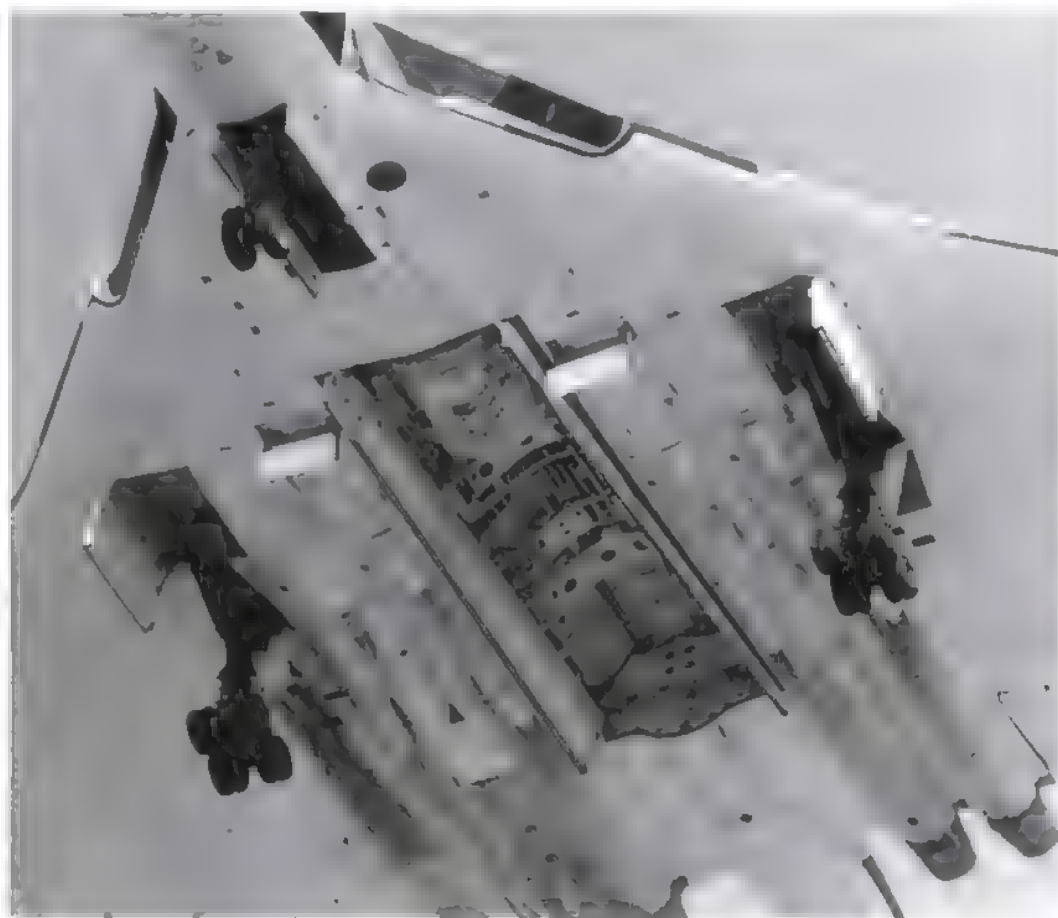
**RIGHT** XM647 pictured on her landing approach. Note the additional fuel tank in the forward end of the bomb bay.

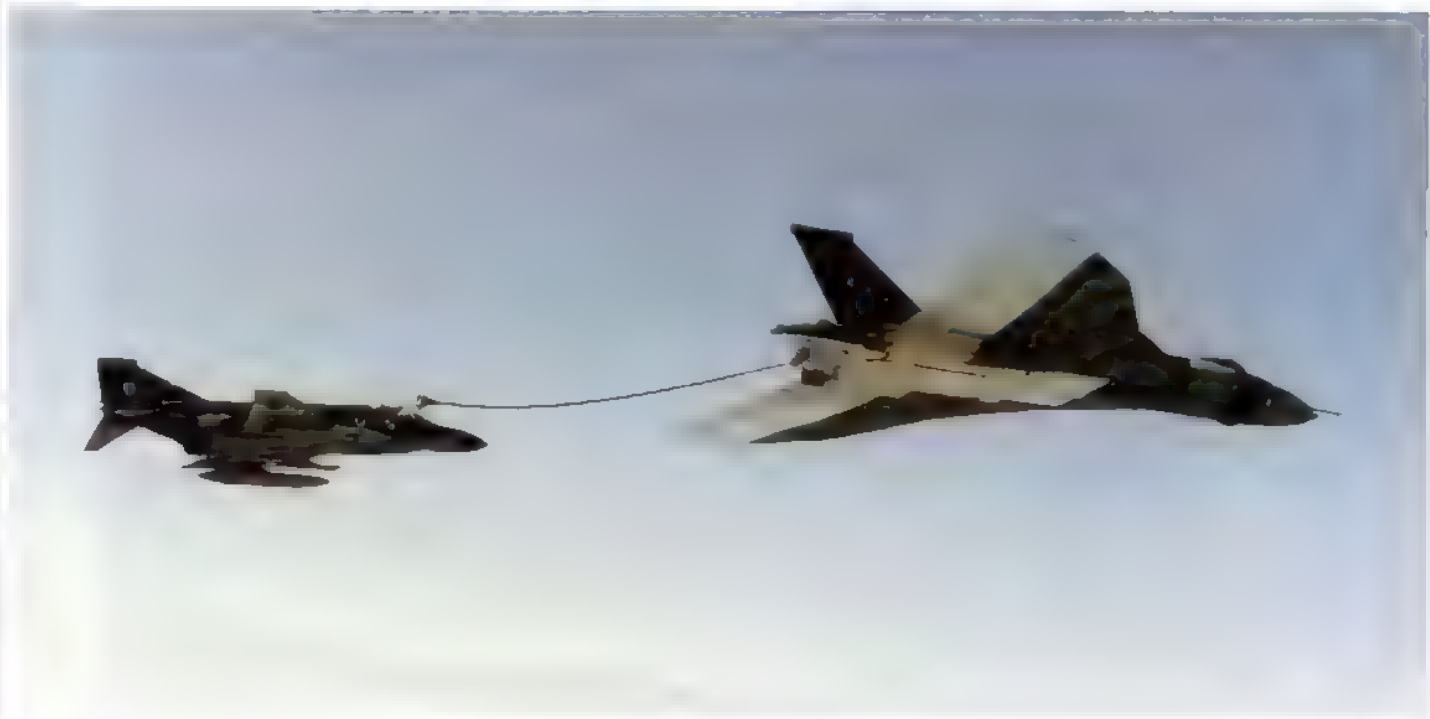
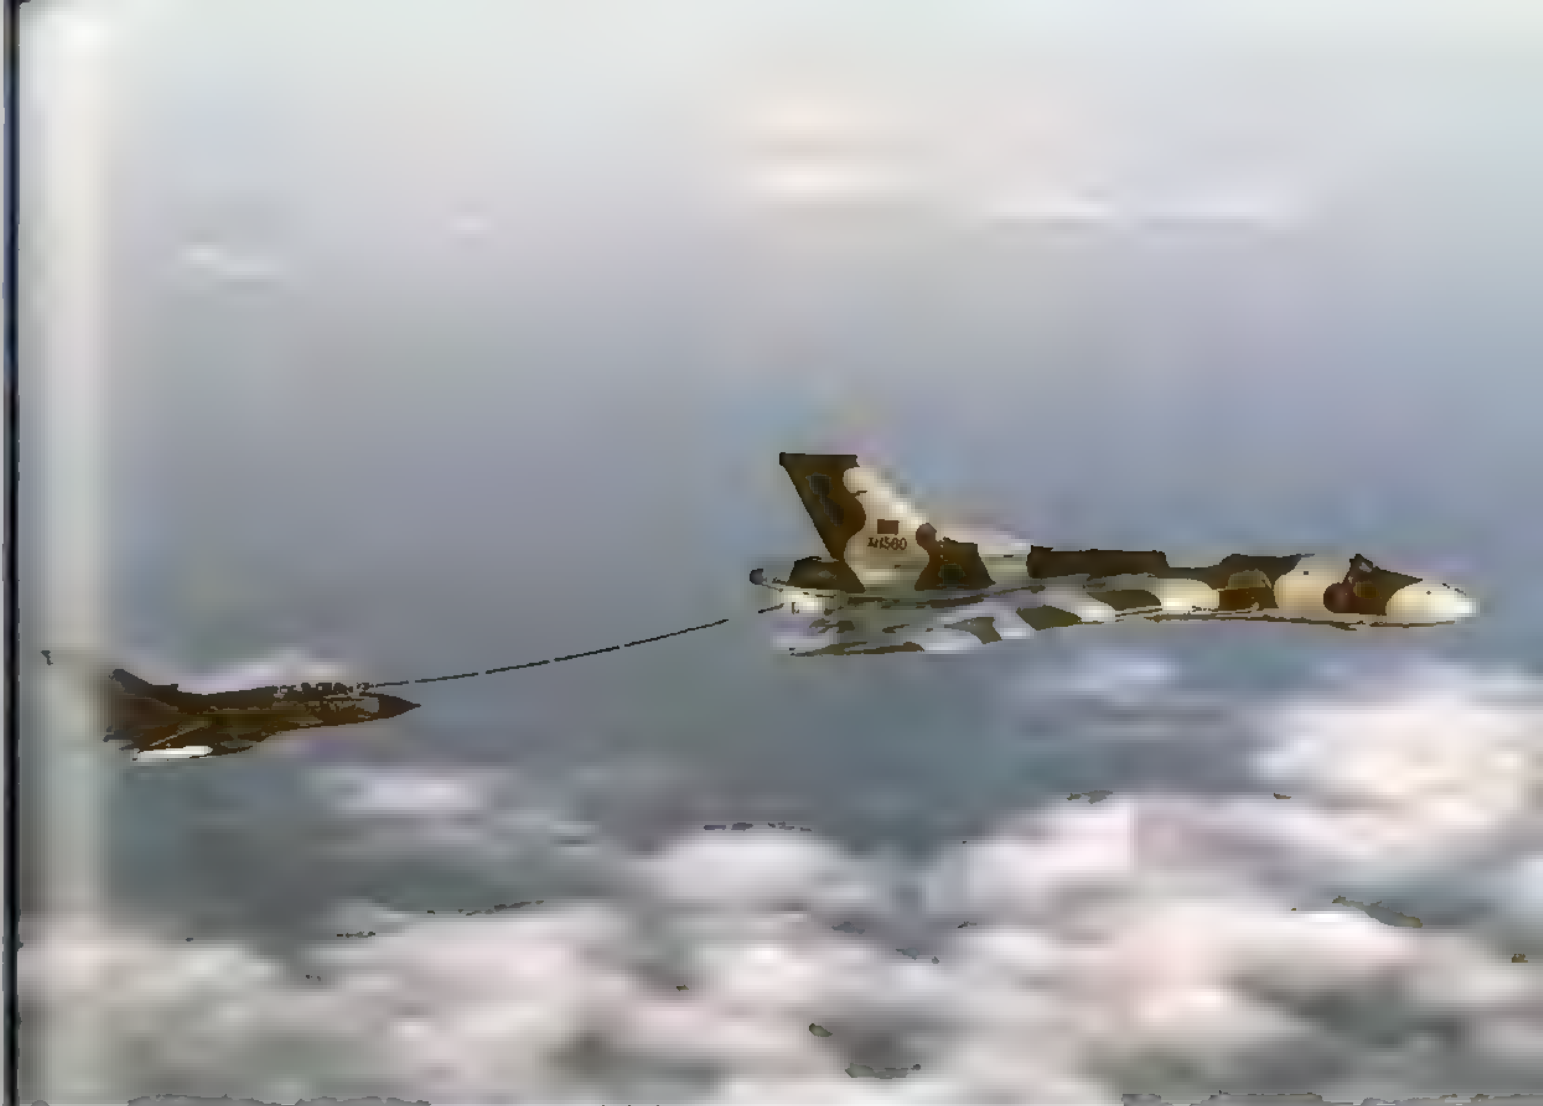
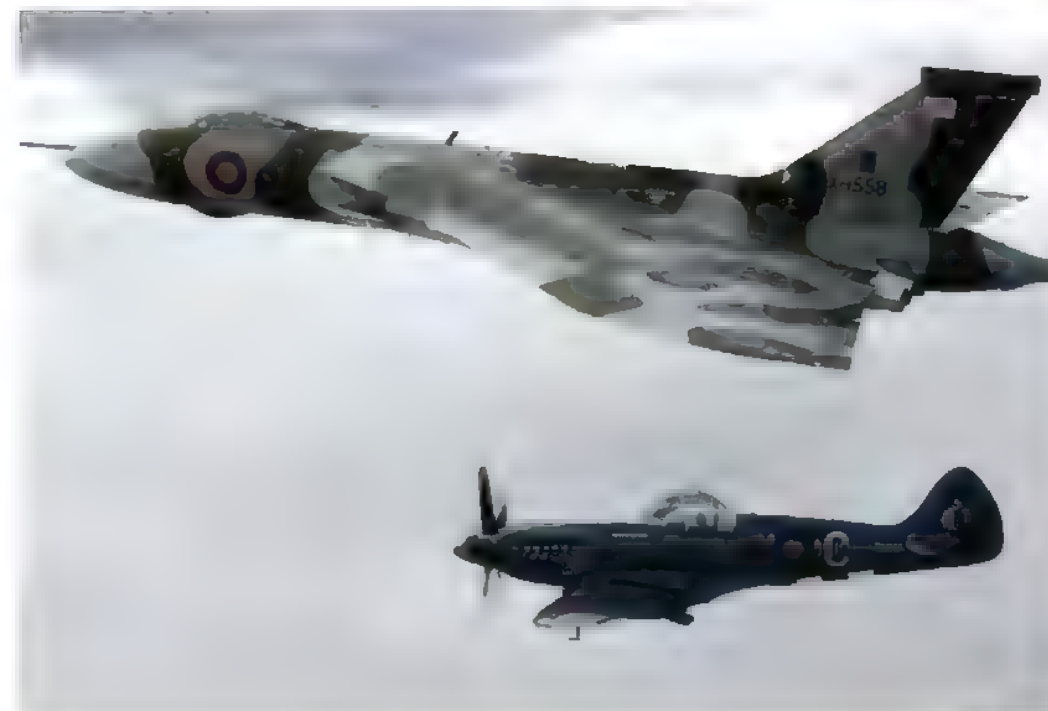
ABOVE The final role for the Vulcan was as a tanker. Vulcan B (K) 2, XH560, on the right, is fitted with a hose drum unit in place of the ECM blister.

available was the Vulcan, and six of these aircraft were selected for modification to the tanker role. This conversion involved removing the ECM blister and equipments in the tail, and replacing them with a Flight Refuelling Mk 17B hose drum unit. To increase the aircraft's fuel carrying ability, three 1,000-gallon auxiliary fuel tanks were installed in the bomb bay.

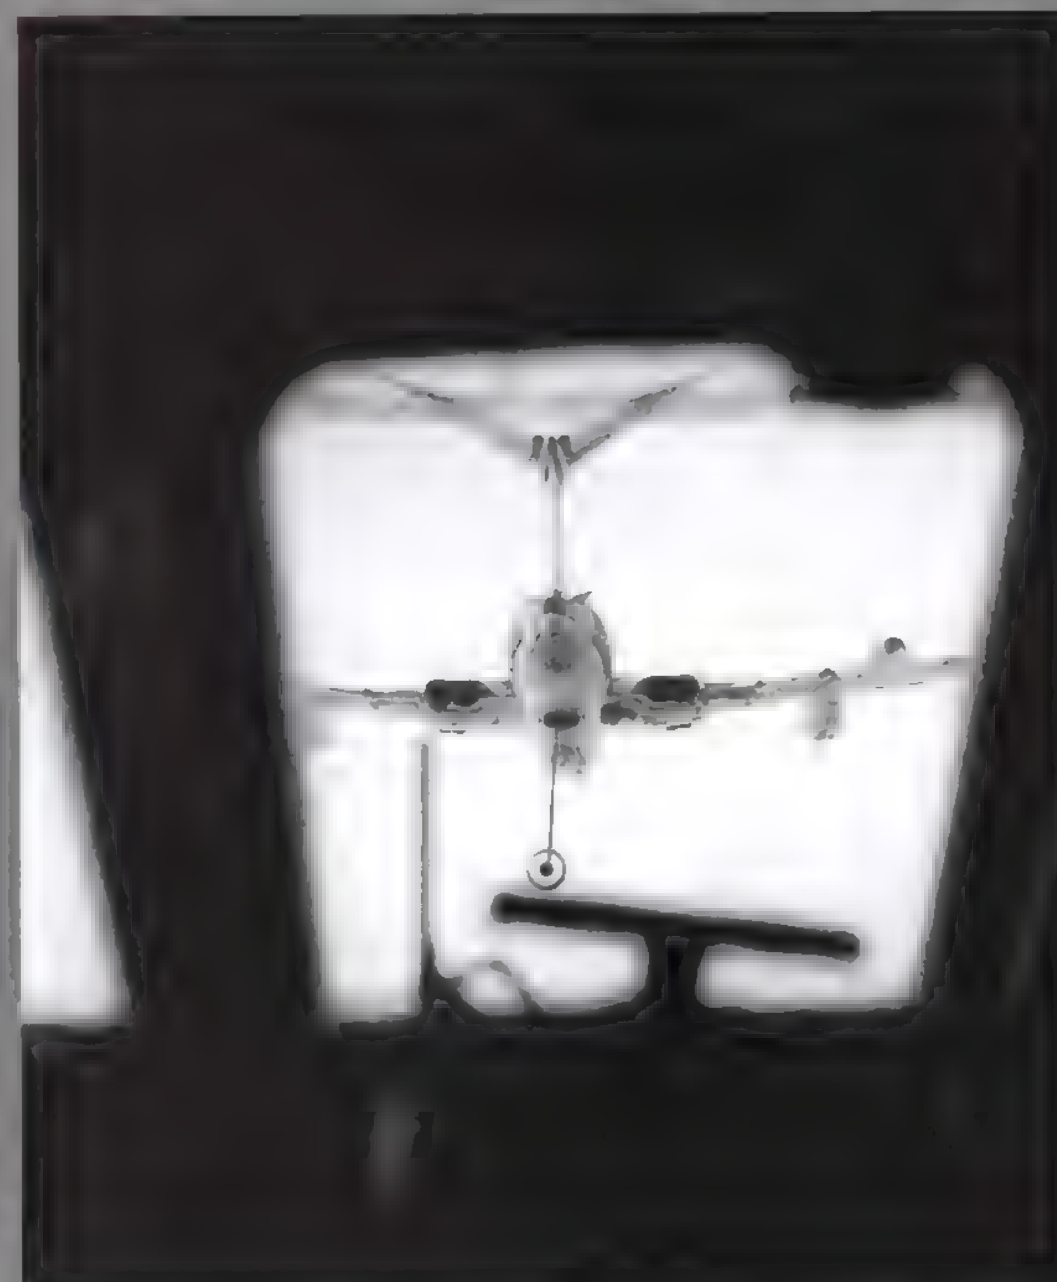
**RIGHT** The view from the cockpit of a Vulcan as it edges into position to take fuel from a Victor tanker.

For refuelling in flight, the Vulcan had a refuelling probe located centrally on the nose and linked into the normal refuelling lines. One feature of the Vulcan that caused a minor problem, particularly at night, was that the probe and drogue were not in the pilot's direct field of vision as he

The Vulcan's refuelling system was designed to be able to refuel from a Victor tanker or a tanker with a different drogue.

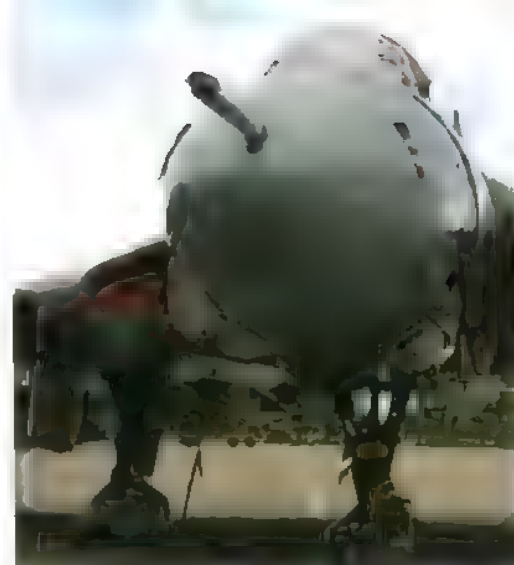
**ABOVE** Flight refuelling probe. Jonathan Falconer

The upper part of the nose section is of orthodox metal construction. It houses the flight-refuelling probe, the scanner for the H2S bombing radar with its associated pneumatic system, and a 12-gallon tank for de-icing fluid for the windscreen. Below the metal structure is a dielectric radome made of fibreglass and hycar (a lightweight first

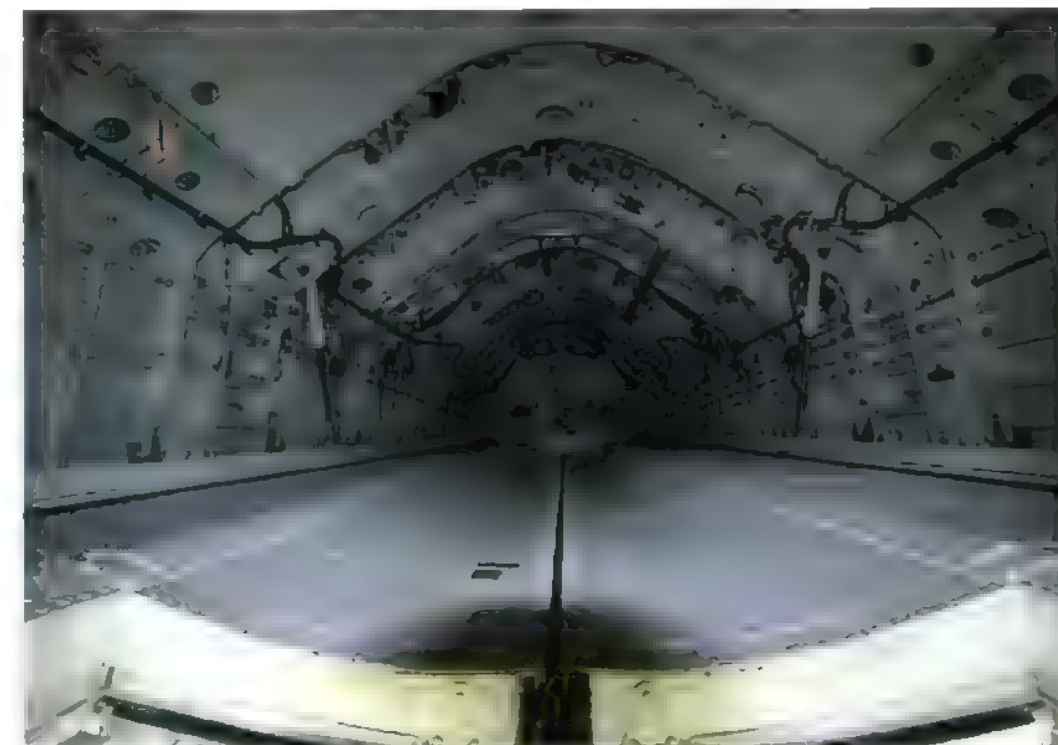
**LEFT** The bomb bay interior. Dave Morns

The area between the front and the rear spars incorporates the bomb bay, which occupies the entire centre section of the aircraft. When the bomb bay doors are open, they fold
